SAFETY BULLETIN

Safety Bulletin No.	2025 - 02	Date Issued	May 2025
Subject	Aerobridge Operations		
Area of Concern	Darwin International Airport Aerobridge 1, 2 and 5		
Issued By	Melanie Cobbin – Head of Airport Operations

This Safety Bulletin is issued to highlight the safe operation of Aerobridges - number 1, 2 and 5 at Darwin International Airport (DIA).

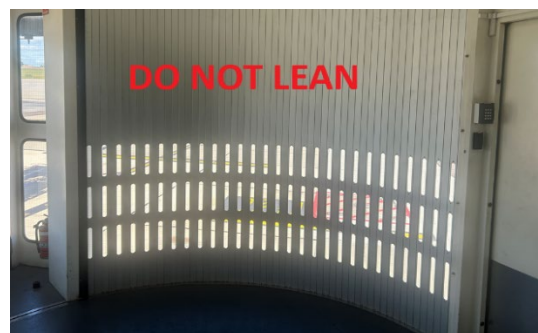
- **Under no circumstances are persons to lean on the area as per the image.**
- **Warning signage placed on the closest solid structure to the roller door**

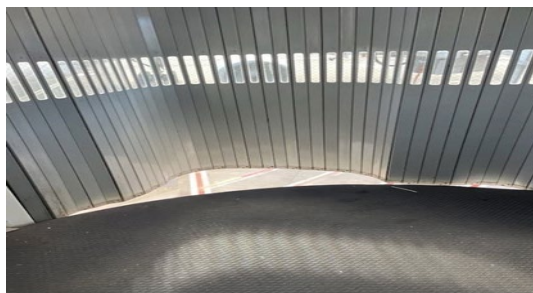
- Indicative photo of the location of the 'At Risk Area' on AB.

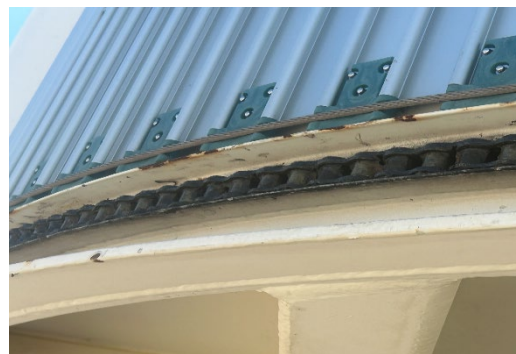
- A physical inspection of the steel cable that holds the roller door in its position at the bottom has been checked. The cable is tightly anchored at both ends.

1. A physical check of the AB cable which provides a stable point to point fixture when driven to final position has been checked.
2. The AB walls have been stress tested.
3. Signage in place on the closest solid area.
4. Maintenance schedule is under review
5. Additional information sought from manufacturer

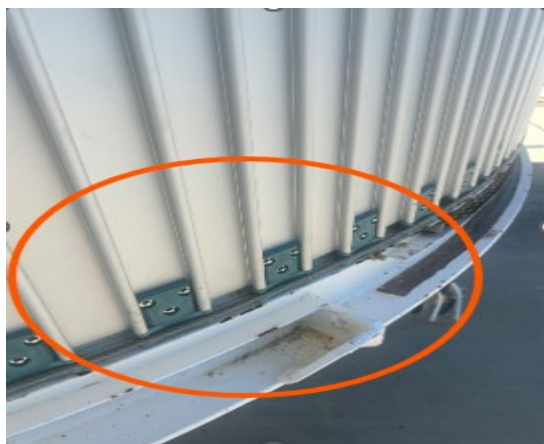
- Cable Inspected and tested.

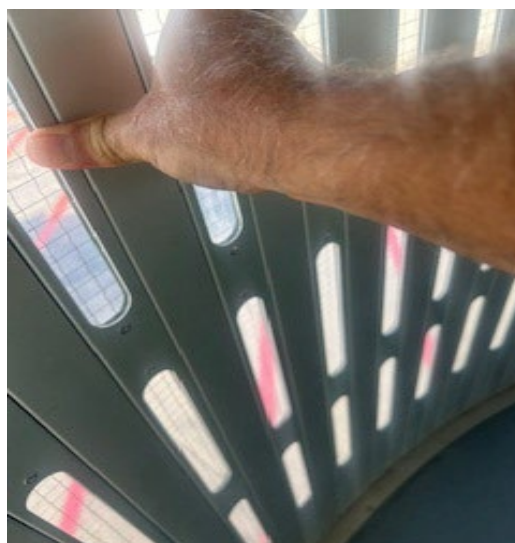
- AB roller doors stress tested.
