SAFETY BULLETIN

Safety Bulletin No.	2023 05	Date Issued	01 October 2023
Subject	GA Aprons - Aircraft Manoeuvring and Parking		
Area of Concern	Darwin Airside		
Issued By	Mike Clancy - Airside Manager

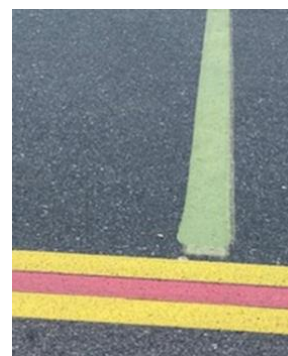
Lime green lease lines are used to designate apron areas that are for the exclusive use of the respective operators – parked aircraft on adjacent apron areas cannot extend across the lease lines and under no circumstances are aircraft permitted to taxi across or use any part of a leased apron when arriving to or departing from another apron area.
